NRL Memorandum Report 1967

Examination of the Corrosion and Salt Contamination of Structural Metal From the USS TECUMSEH

EXAMINATION OF THE CORROSION AND SALT
CONTAMINATION OF STRUCTURAL METAL
FROM THE USS TECUMSEH

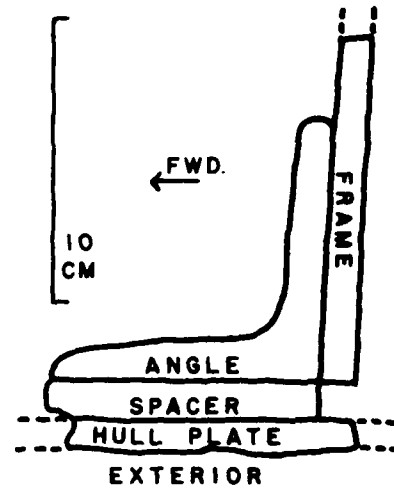
The specimens brought up by divers for study were a portion of a blower housing, two pieces of cast iron engine room deck plate, and of greatest interest, a section of the hull including hull plating and a portion of a transverse frame. This ship was not of ironclad construction. Although some wood was used in its construction, the hull was built principally of wrought iron plates 1/2 inch thick joined by rivetting. The hull specimen was cut from the "B" strake on the starboard side near frame 42. Roughly 60 x 40 cm in size, it consisted of exterior hull plating, a spacer, and frame plate fastened to 9 cm angle iron by 6 rivets (Fig. 1). The specimens of deck plate were taken from the same location. The hull specimen and the deck plate were selected for careful study as being of particular interest and generally representative of the condition of all the iron structure and objects in the ship. The hull specimen and the large piece of deck plate were sectioned with a bandsaw into manageable pieces for laboratory examination.

Fig. 1 - Section of hull structure from the Tecumseh

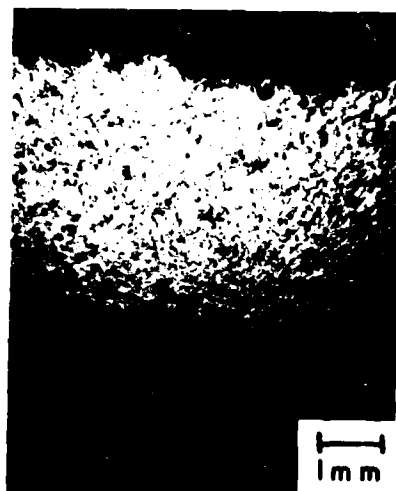
of the metal varied from 9 to 12 mm (0.35 to 0.47 in.). The depth of the corrosion may be two or three times as great near the mud line (1). This possibility should be checked for by drilling a few holes in the hull in this area. A polished section of the hull plating showed numerous slag inclusions, flattened and aligned by the rolling process. Some were several inches long in the fore-and-aft direction. The frame plate contained a crack or planar inclusion extending 2 1/2 in. from the lower edge and several inches in length. It might have been formed by the enfolding of the billet surface during working. The cast iron engine room deck plate specimen was more severely corroded. The metal was perforated in places, and had a maximum thickness (exclusive of the rim) of 8 mm (0.3 in.). Judging from the oxide layer, the original minimum thickness may have been 9 mm (0.35 in.). An appreciable fraction of the metal is composed of inclusions, many as large as 0.1 mm. These are not flattened or oriented, which confirms that the deck plates were cast (Fig. 3).

Fig. 3 - Polished section of cast iron deck plate and oxide layers showing inclusions in the metal (perpendicular to the plane of the plate, not etched)

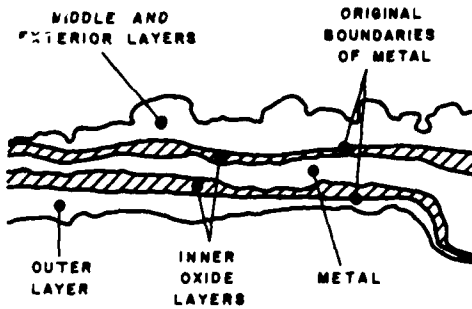
The scale formed on the cast deck plate (Fig. 8) was in layers similar to that on the wrought iron. The inner layer was a strong but brittle material which is formed by the graphitic corrosion (3) of gray cast iron. The original shape of the metal was preserved in the outline of this layer. On the upper surface of the deck plate (facing downward in the sunken hull) the outer layers of scale were nodular in form, with the middle layer weaker and more porous than the corresponding layer on the wrought iron. The maximum thickness was about 15 mm. On the lower side of the plate (facing upward in the sunken hull) the deposit was 2 - 8 mm thick and lacked the black and white calcareous external layer. It was relatively dense and hard, variegated red, brown, and black, and appeared to contain biological remains.

Fig. 8 - Sawn section of deck plate, near the edge. The original lower surface of the plate was flat, except for the rim around the edge, while the upper surface had a pattern of raised dia -

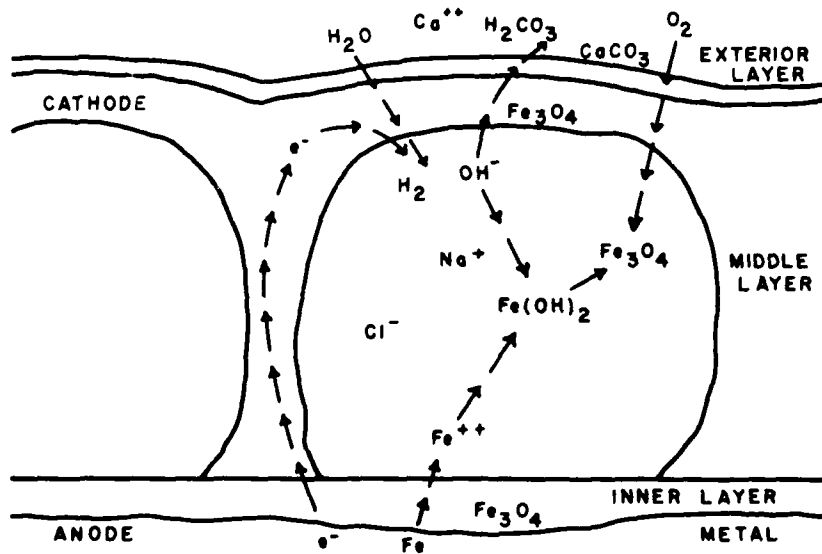
The observed characteristics of the scale are compatible with the corrosion mechanisms described by Evans (4). Figure 9 is a schematic representation of a porous oxide layer, in contact with the metal, and permeated with seawater. The oxide is cathodic to the metal, so that a galvanic corrosion cell is formed. Ferrous chloride is formed at the metal surface and sodium hydroxide at the oxide surface. These come together and form ferrous hydroxide which is further oxidized by oxygen diffusing into the scale. The oxides thus are formed within the scale, causing it to grow outward from the region in which the mobile ferrous ions and hydroxyl ions meet to form the insoluble ferrous hydroxide. This region is apparently in the middle scale layer. The rate at which the corrosion proceeds is controlled by the rate at which oxygen diffuses into the scale from the

surrounding water. Meanwhile, the slight alkalinity in the scale causes calcium carbonate to deposit forming the exterior layer. This dense layer ultimately limits the diffusion of oxygen into the scale and virtually halts the corrosion of the metal over which it lies.

Fig. 9 - Scale-forming reactions
